EFFECTS ON A VEHICLE IMPACTING A
CONCRETE SAFETY SHAPE BARRIER AT
A LOW SPEED AND A LARGE ANGLE

1. REPORT NO. CA/TL 86/02		2. GOVERNMENT ACCESSION NO.		3. RECIPIENT'S CATALOG NO.	
4. TITLE AND SUBTITLE Effects on a Vehicle Impacting a Concrete Safety Shape Barrier at a Low Speed and a Large Angle				5. REPORT DATE July 1986

The following conclusions are based on the results of an 1860 lb vehicle/27.4 mph/52° impact test, Test 431, into a safety shape concrete barrier.

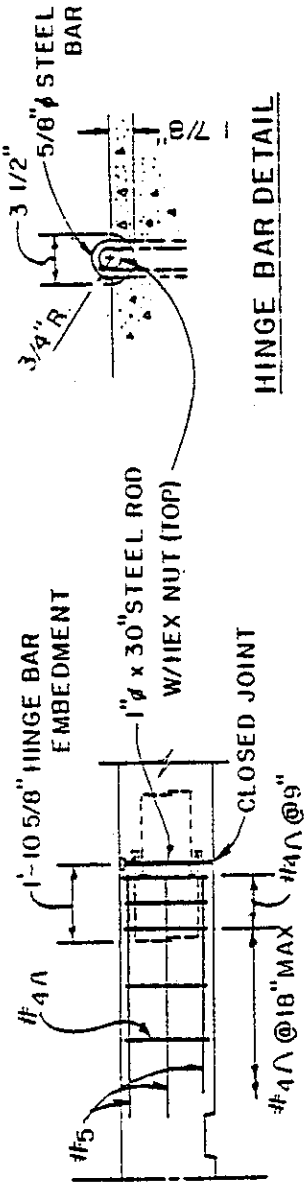
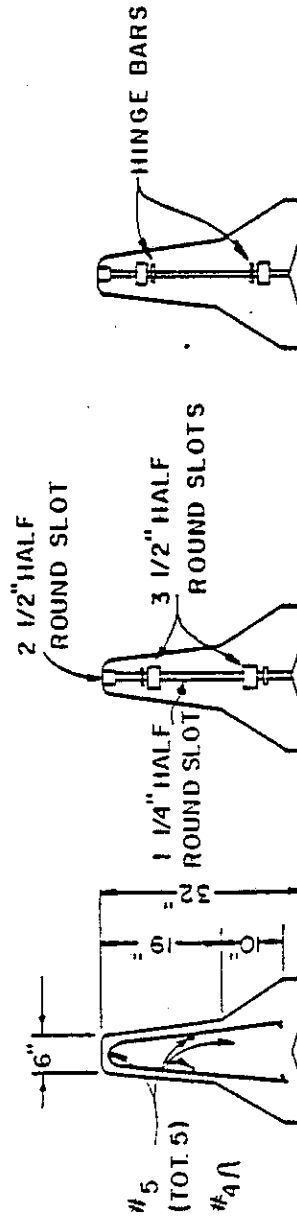
FIGURE 2 --Test Barrier

A former test barrier similar to Caltrans Temporary Railing Type K was used for the test. It was 80 feet long and composed of four 20 foot sections. The barrier had a safety shape (New Jersey) profile identical to the profile of the Caltrans Type 50 Concrete Barrier. It was placed on top of an asphaltic concrete surface. It was bolted to a footing at one point and backed up with two barrier segments, set perpendicular to the test barrier near impact point, to minimize barrier movement. The test barrier is shown in Figures 1 and 2.

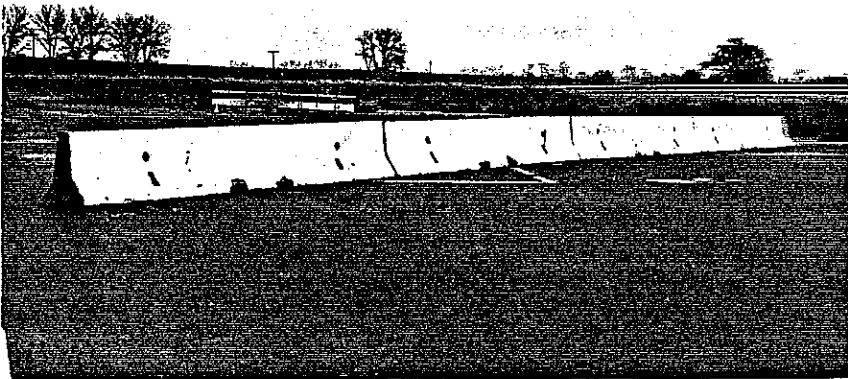
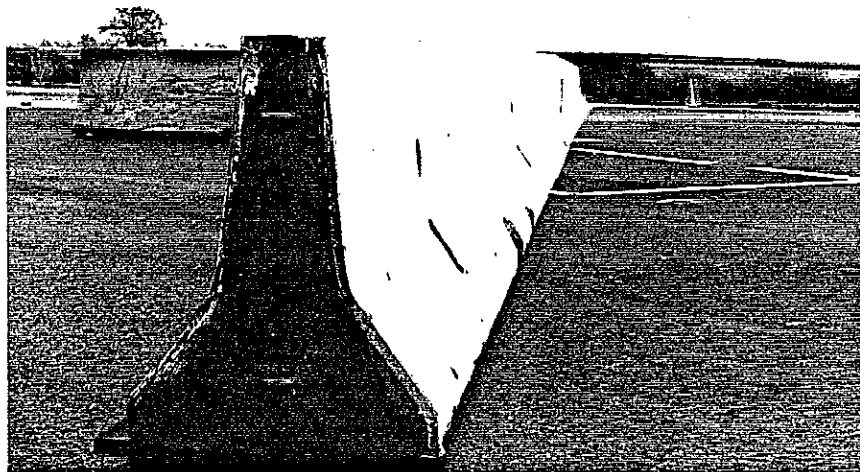
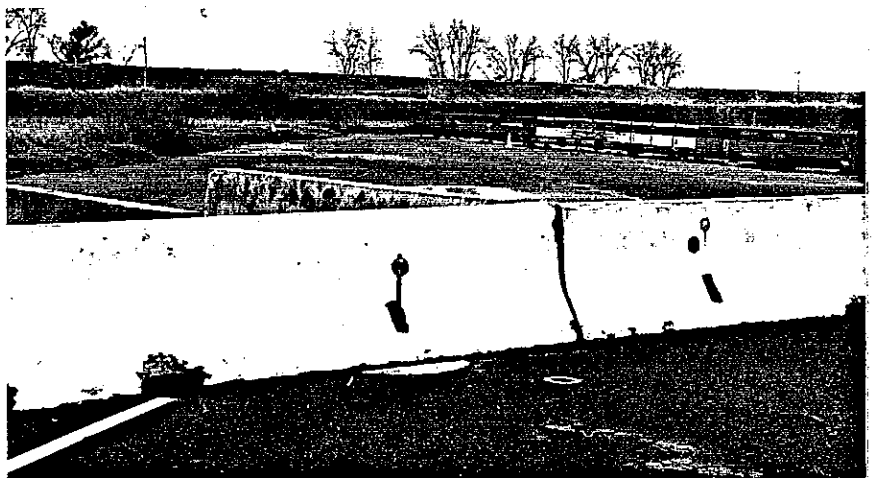
FIGURE 3 - Car Location With Respect to the Barrier Before Impact

The test vehicle was a 1975 Honda Civic weighing 1860 lb, not including the dummy, Figure 3. It was in good condition, free of body damage and without missing structural parts. All equipment on the vehicle was standard. The engine was front mounted. No ballast was used. Vehicle dimensions are shown in Figure A1 in Appendix A.

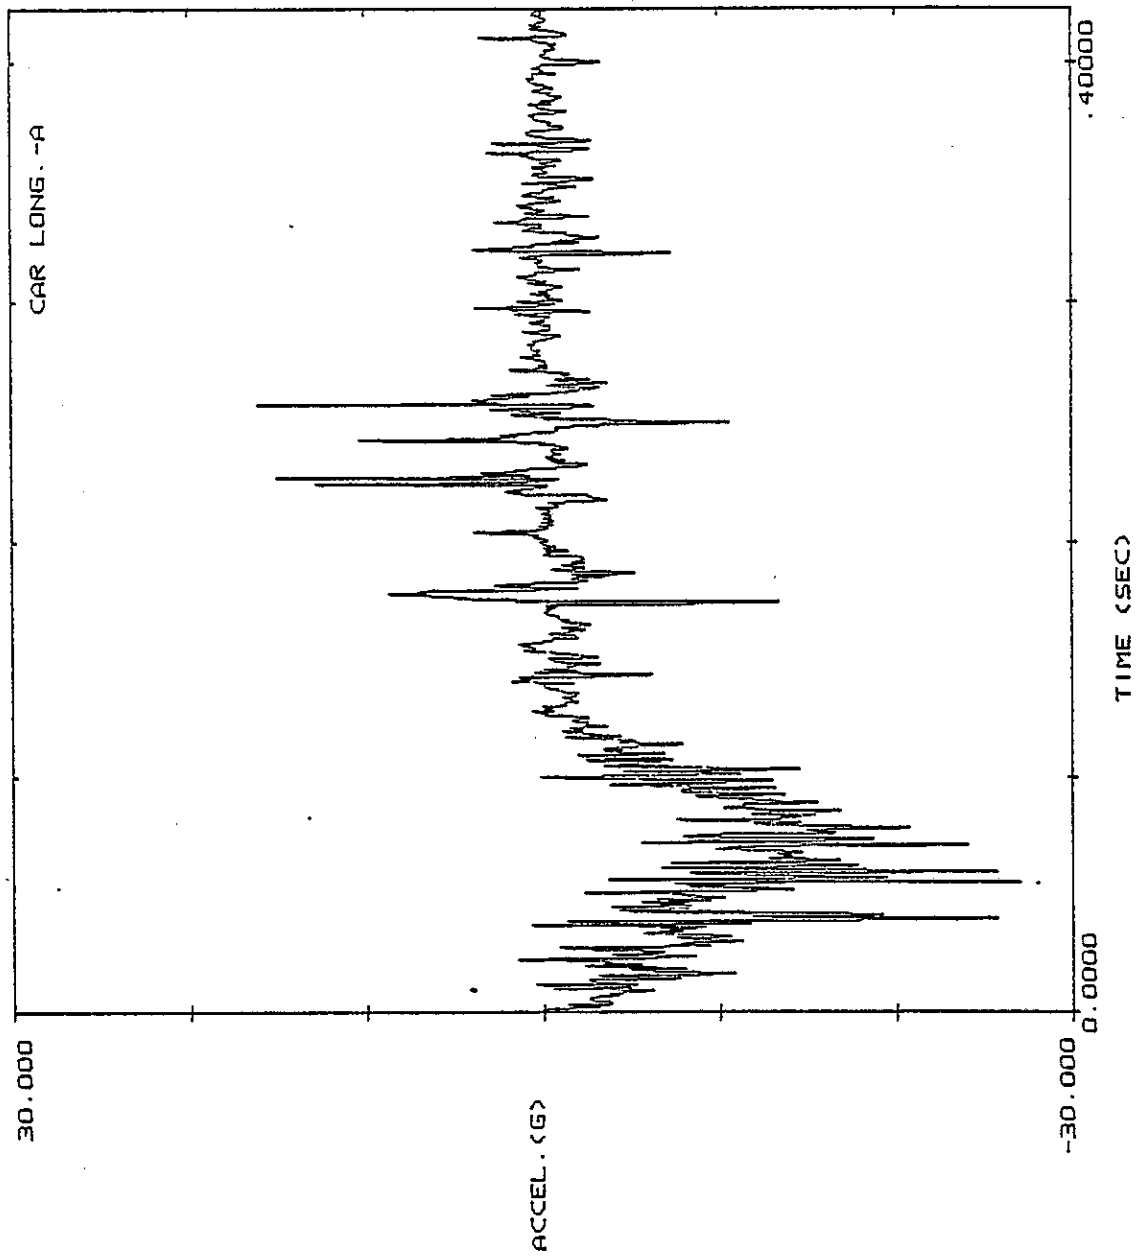
FIGURE C7 - Vehicle Longitudinal Acceleration vs Time.

Actual 50 ms accelerations in Test 431 were - 5.5 g's lateral and -12.4 g's longitudinal. These values show that in the lateral direction, the test value was slightly higher than the limit, about 0.5 g, and in the longitudinal direction, the test value obviously exceeded the accepted limit. It should be noted that cars impacting concrete median barriers currently in use, equal or exceed the -5 g limit in the lateral direction in crash tests(4). It appears that the lateral acceleration cannot be reduced below -5 g's when a passenger vehicle impacts rigid barriers at angles of 15° to 25° and speeds of 60 mph.

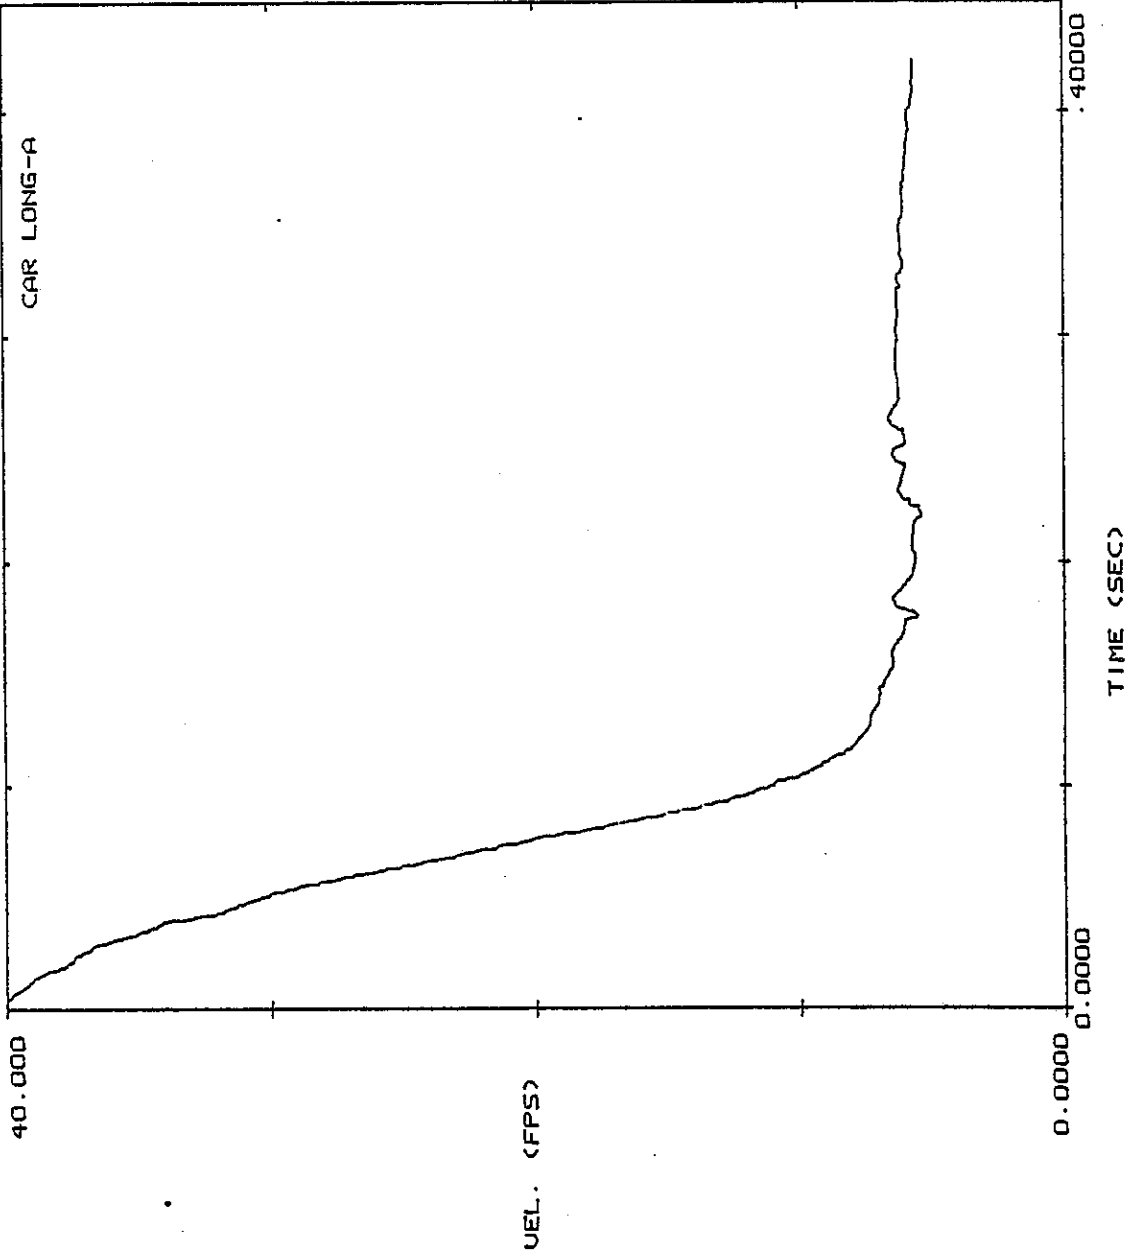
FIGURE C11 - Vehicle Longitudinal Velocity vs Time.

Distance vs Time and the plots used to determine Occupant Impact Velocity. Figures C11 and C12 show blown up plots of Vehicle Longitudinal Velocity and Distance vs Time.

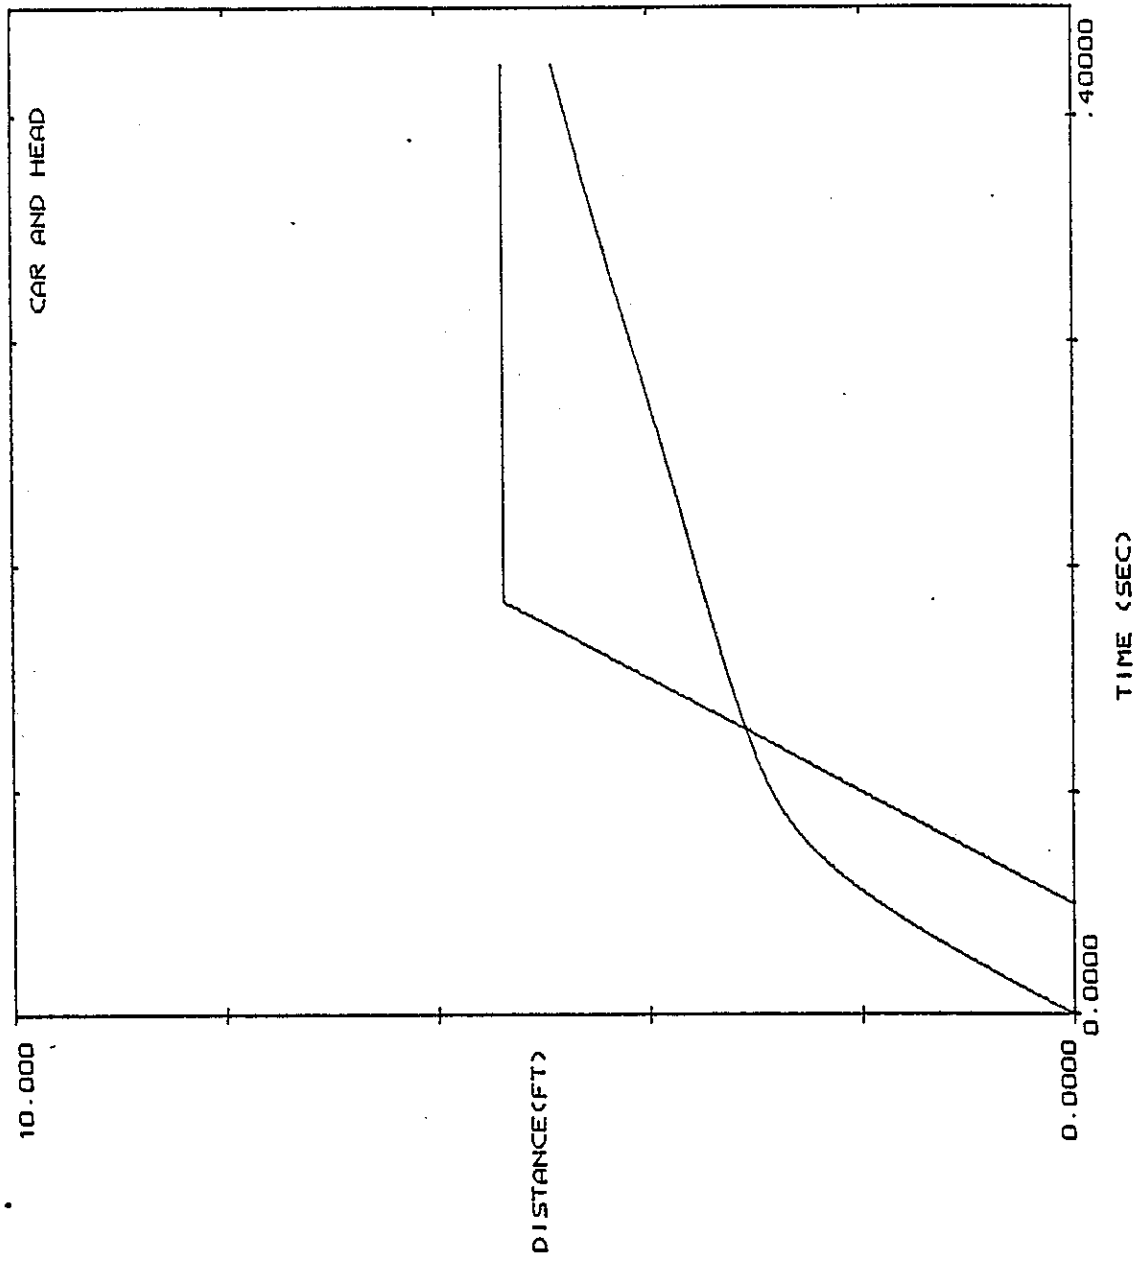
FIGURE C12 - Dummy (Theoretical) and Vehicle Longitudinal Distance vs Time Used to Find Occupant Impact Velocity.

The occupant impact velocity is theoretical; however, on the plot of Distance vs Time Figure C4, the curves can be visualized as representing the car windshield and the driver's head. It is assumed that the head starts out two feet behind the windshield. The point where the distance curves cross represents the impact between the head and the windshield, because the windshield has slowed down from the impact velocity and the head has not. The time when the windshield/head impact occurs (rattlespace time) is carried to the plot of velocity vs time. The occupant impact velocity is the difference between the vehicle impact velocity and the vehicle velocity at the end of the rattlespace time.
